INSPECTION VISIT REPORT

IVR - 8117433193 - Sr. No.1. - Rev. 00

Item Description:						
P.O. Item No.	Item Code	Item Description	UOM	P.O. Quantity	Offered Quantity	Accepted Quantity
1	----	Performance test on Pneumatic Q turn Actuator as per EN15714-3, Actuator Model:- MD100-F10 Sr. No:- 200701022/07/20 5,00,000 cycles as per BS EN 15714-3:2009	Nos.	01	01	01
2	----	Performance test on Pneumatic Q turn Actuator as per EN15714-3, Actuator Model:- MS63-F05 Sr. No:- 200701013/07/20, 5,00,000 cycles as per BS EN 15714-3:2009	Nos.	01	01	01
Reference Documents:						
Sr. No.	Document Name	Client Document Number	Vendor Document Number	Approval Status

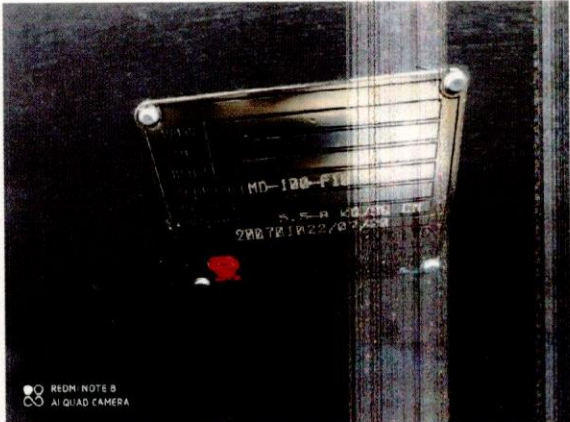
10)	Marking On name Plate verified : Manufactures Name , Model , serial no ,Maximum Operating Pressure , Fail safe Return actuator , Actuator designation verified.- Found in order as per drawing & data sheet.						
Documents Reviewed:

Inspection Pictures:	
Marking Verification of Actuator	Life Cycle test set up

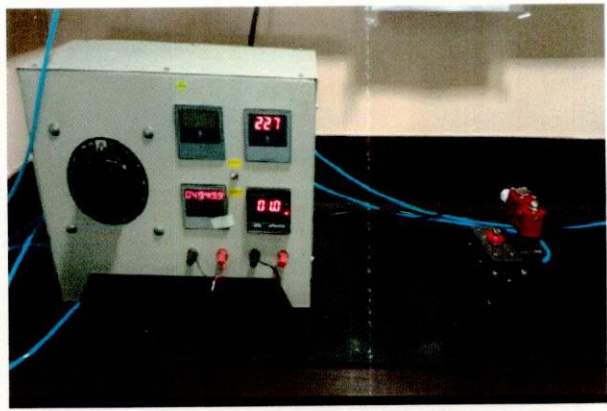
5)	Endurance test witnessed :- 5,00,000 Cycles with stroking time less than 5 seconds (actual- 2 seconds) with load at least 60 % of the run torque at 5.5 bar pressure; Witnessed Torque values at start & end of the test & found not less than 90% of initial value as per below table.						
	Torque test Actuator Model : MD100-F10, Serial no : 200701022/07/20						
	Pressure	Torque Before Cycle test at Ambient temp (28 Deg. C)	Torque After 5,00,000 Cycle test at Ambient temp (29 Deg. C)	Test Result			
	3 Bar(g)	9.43 kg -m	8.95 kg -m	Passed			
	4 Bar(g)	12.57 kg-m	11.90 kg -m	Passed			
	5 Bar(g)	15.71 kg -m	14.76 kg -m	Passed

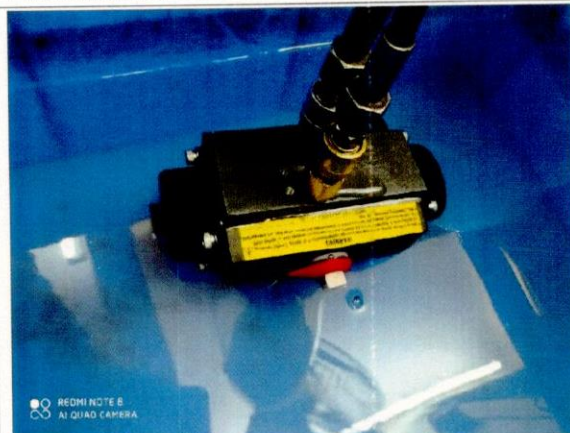
1)	Visual examination & strip test of actuator witnessed before start of cycle test. - No injurious defect were observed- Found acceptable.					
2)	Shell pressure test (Pneumatic) witnessed. - 8 Bar (g) (at 30 deg. C) for duration 60 seconds found acceptable.

Pneumatic Shell test before cycle test

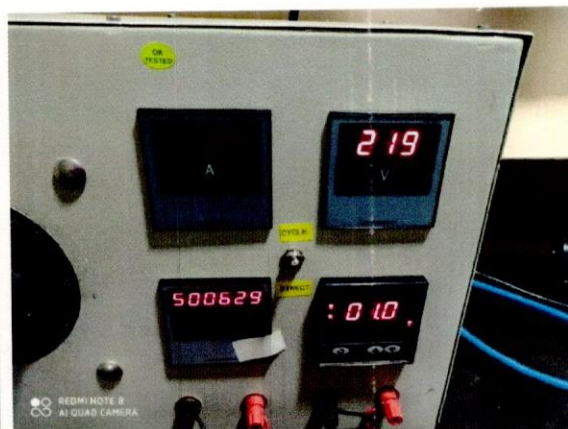
3)	Torque values measured before start of cycle test & recorded. Counter & actuator sealed & cycles started.					
4)	Random monitoring carried out for check of continuity, smoothness & operation.

Check of Cycles
